VEHICLE FIRES CAUSED BY IMPROPER HOSE CLAMP APPLICATION

Charles C. Roberts, Jr., Ph.D., P.E.

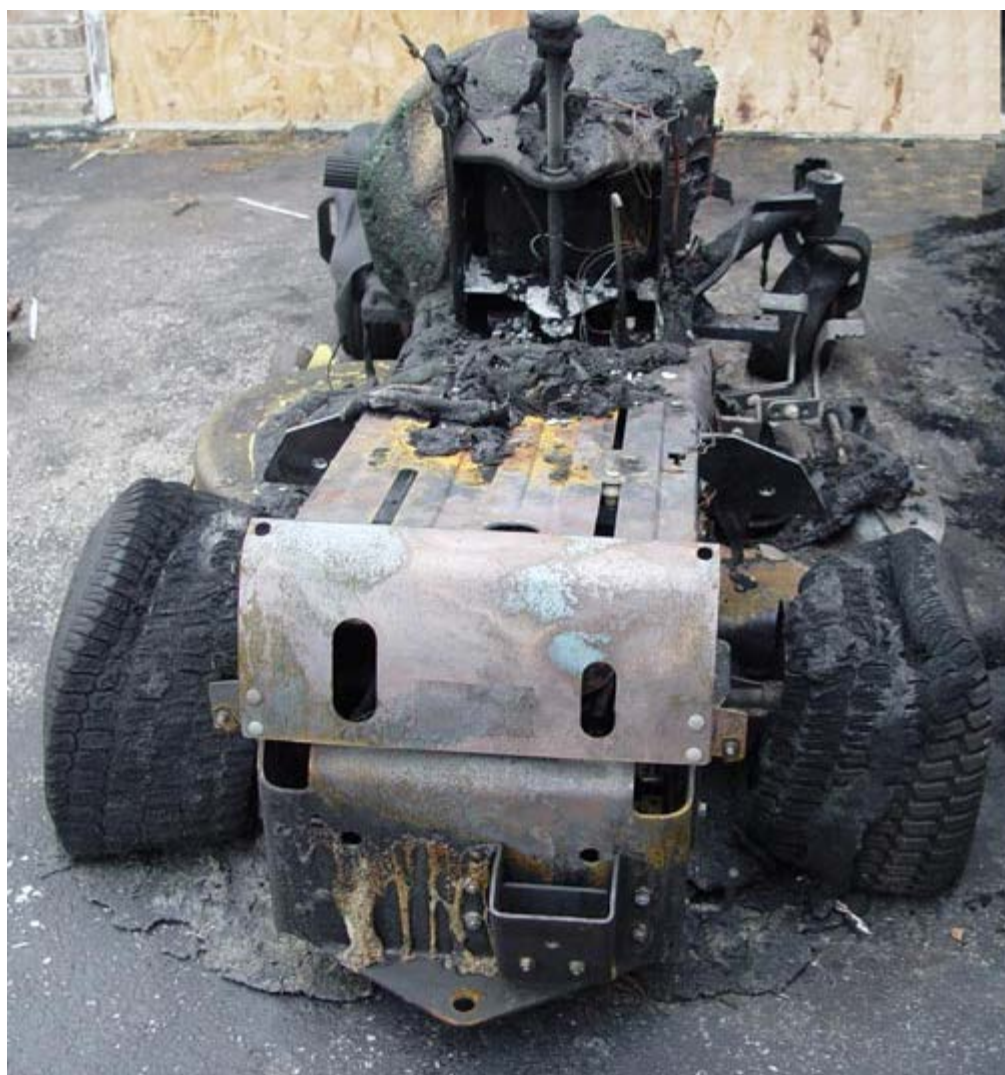
Figure 1

Fuel leakage is a common cause of vehicle fire losses as exemplified in Figure 1. The fuel leakage results in a volatile vapor that can be ignited by electrical discharges or hot surfaces.

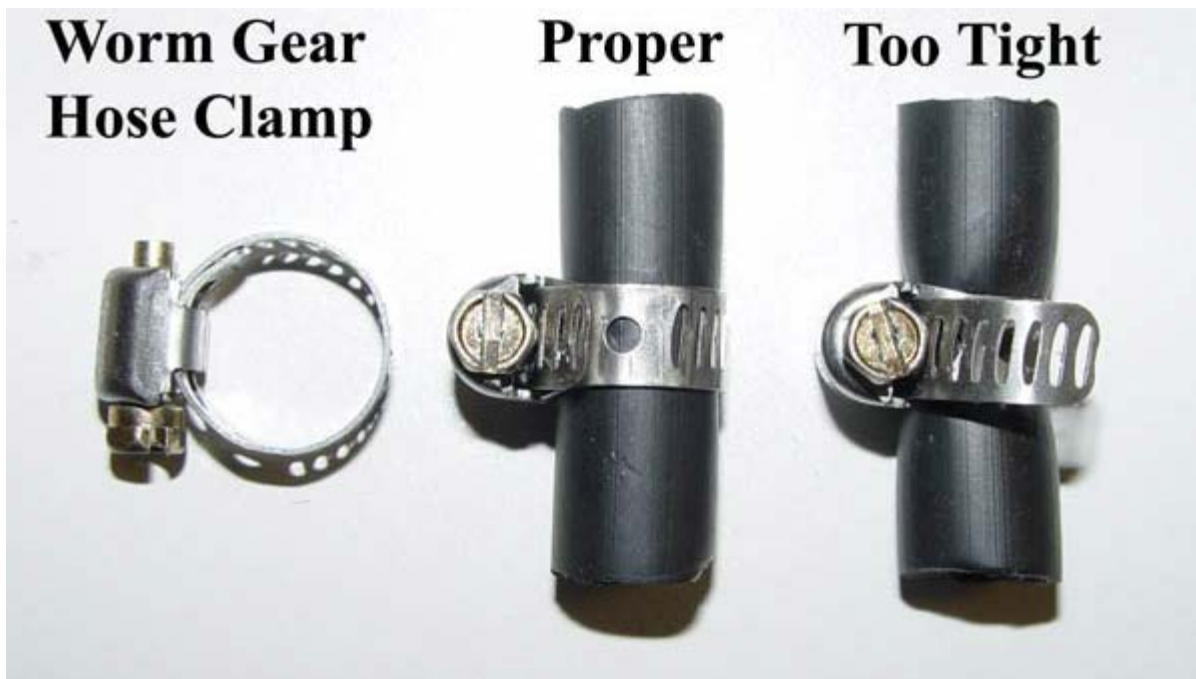
Figure 2 shows a typical worm gear style hose clamp where the screw is tightened to provide clamping force to the hose. The middle hose in the photo depicts the proper application of the hose clamp to the hose with appropriate tightening torque. If the clamp is over tightened or over torqued, the condition to the far right in the photo is shown with severe deformation occurring to the hose. Excessive tightening can lead to the extrusion of rubber through the worn gear slots as shown in Figure 3, which can damage the hose and cause a fuel leak.

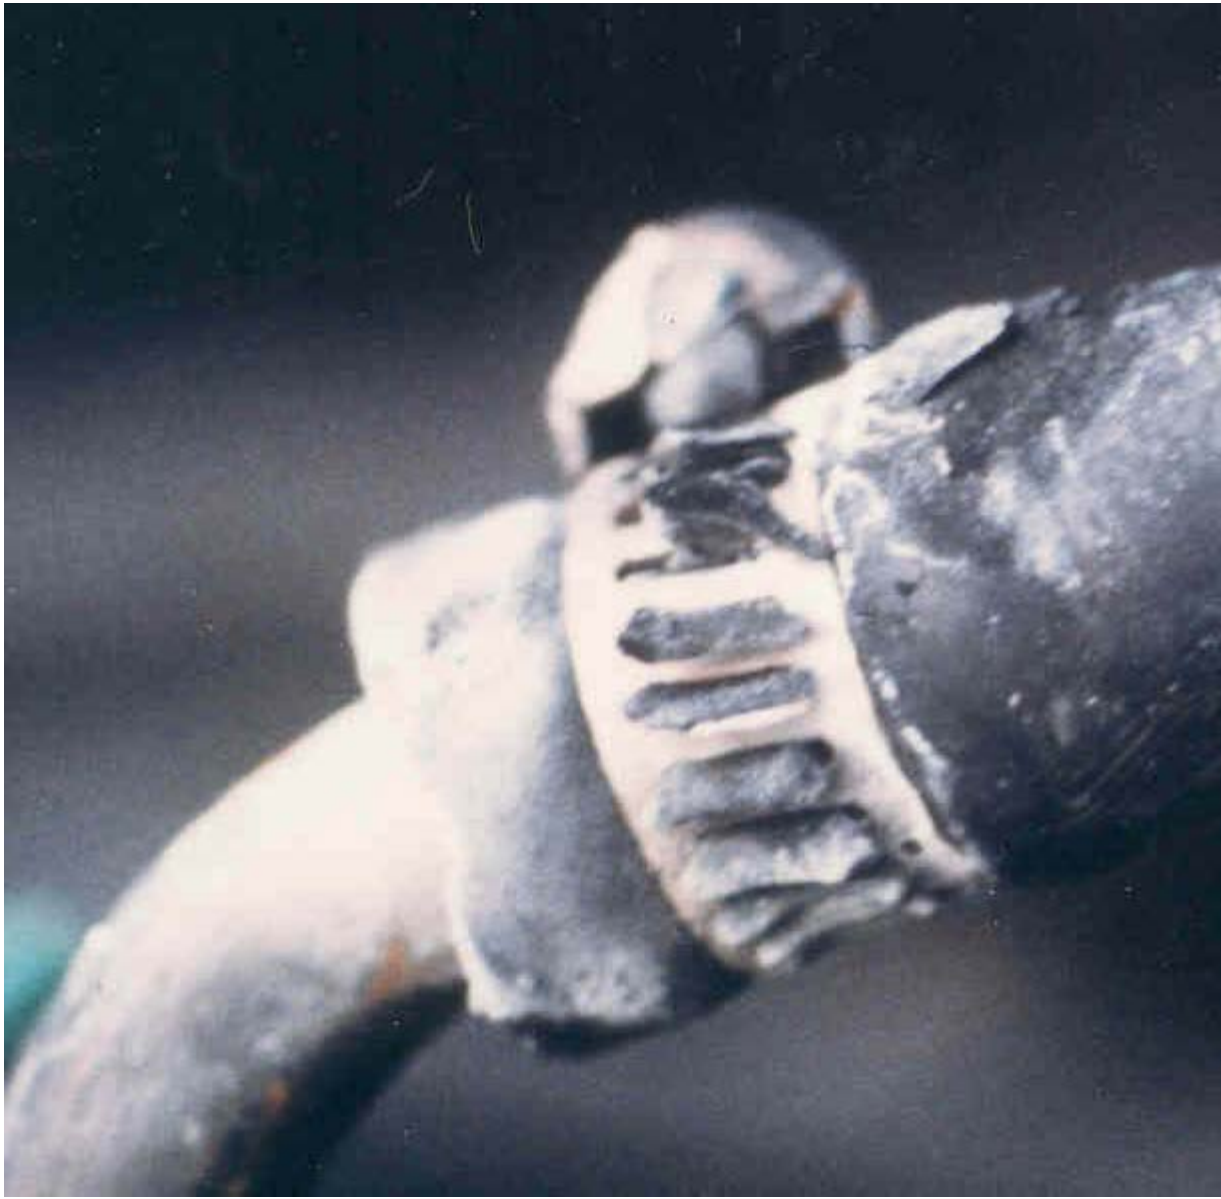
Figure 4 is a view of a hose and clamp which were a source of fuel leakage that caused a fire loss, totaling the vehicle. The extruded rubber through the over tightened hose clamp is quite evident. The hose fitting leaked profusely when tested. The fire was extinguished early, leaving the offending hose clamp, which was installed by the insured, intact. According to the insured, he noticed the leak and merely tightened the clamp to stop the leak, which worked for a short period of time before the hose failed.

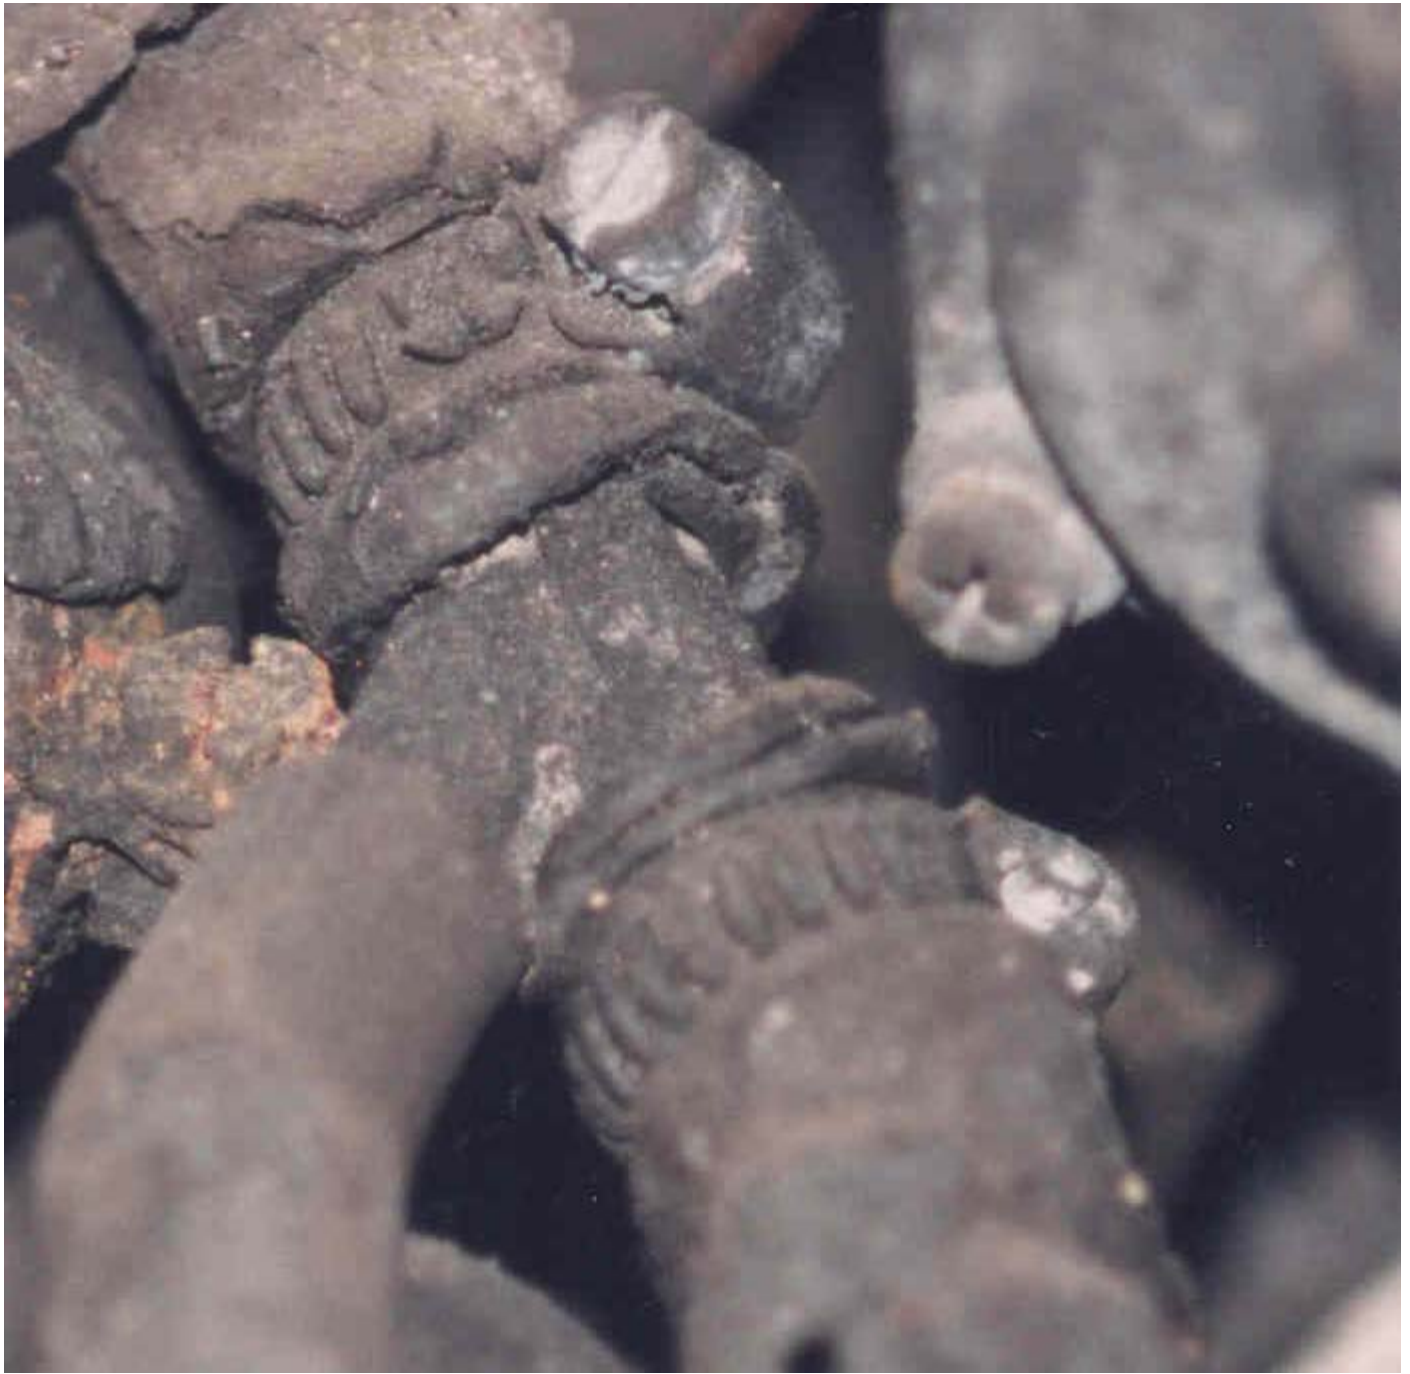
Figure 5

Figures 5 and 6 show views of over tightened hose clamps that caused fires in other vehicles. A long “tail” of worm gear slots is another indicator that the clamp was most likely over tightened.

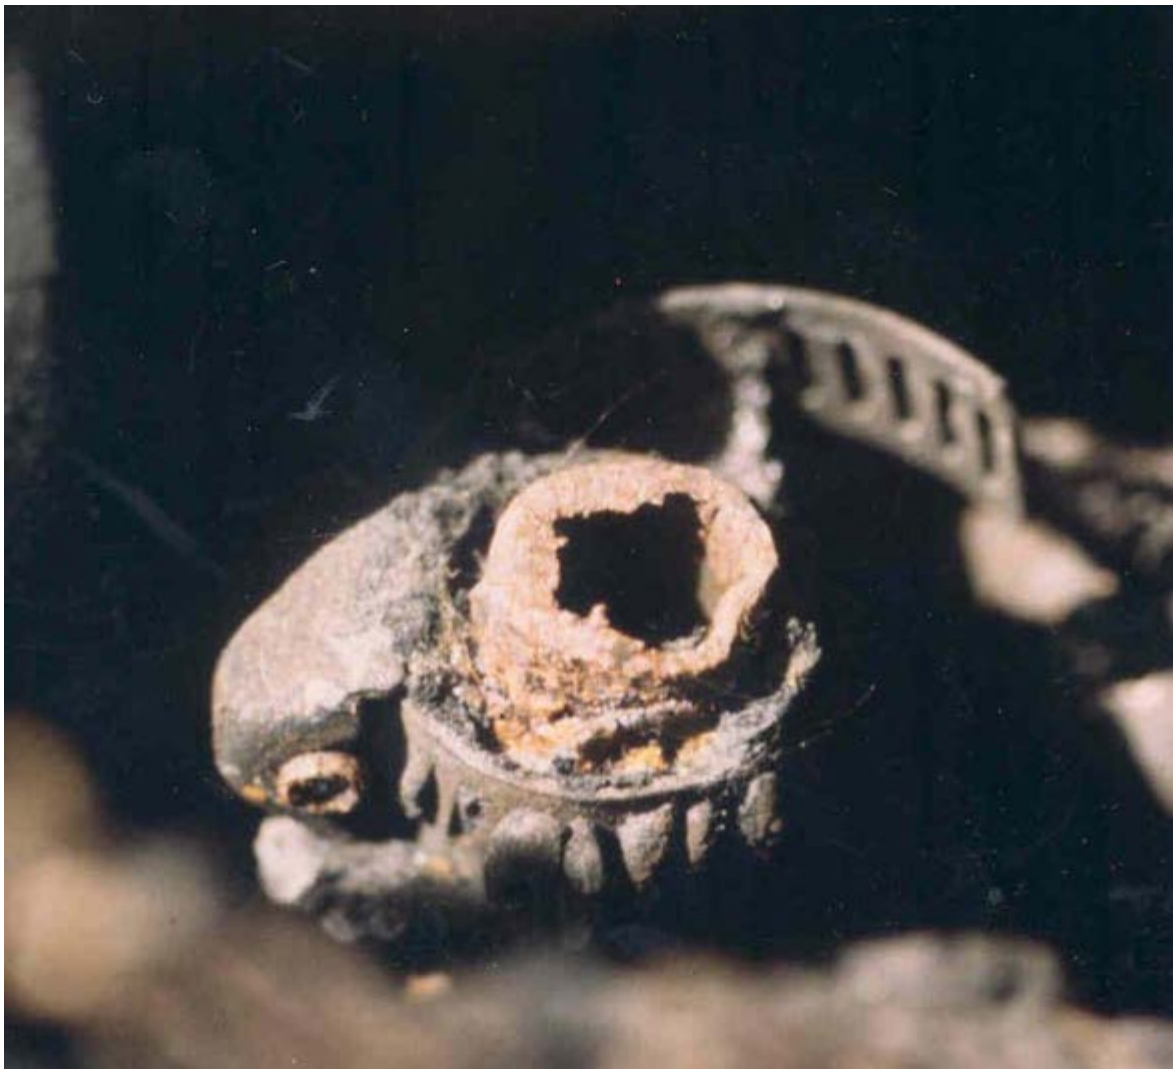
In Figure 7, a repair shop damaged a fuel tube and repaired it by merely sawing it off, replacing it with a rubber hose and worm gear hose clamps. The sharp edges of the fuel tube, plus over tightening of the hose clamp caused fuel leakage, a fire and total loss of the vehicle. Notice the excessively long slotted “tail” in Figure 7 attesting to over tightening as a factor in the loss.

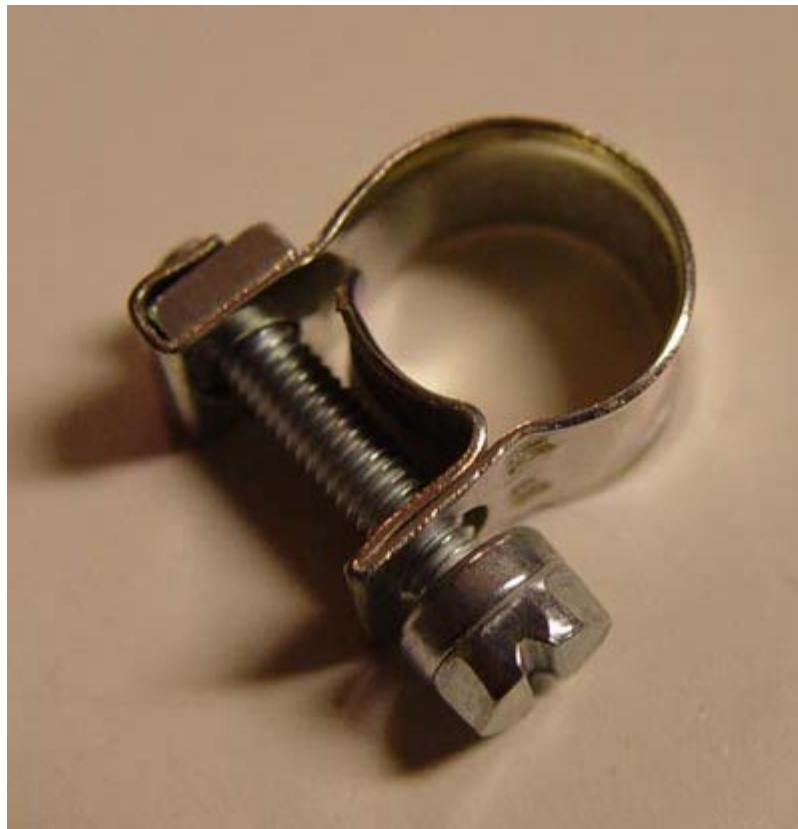
Although worm gear hose clamps are used occasionally by vehicle manufacturers, the nut and bolt design shown in Figure 8 is quite common. The nut and bolt clamp cannot be over tightened as it has a limited range of travel. The problem with the worm gear design is that it can be over tightened by the untrained, which is a misuse of the product. Worm gear hose clamps require specific ranges of tightening torque and should not be tightened above the range limit. When analyzing a fire loss where a fuel leak is suspected, the existence of over tightened worm gear hose clamps may be the cause and also may not be original equipment.
