# AUTOMOBILE ENGINE COOLANT RELATED FIRES

Charles C. Roberts, Jr., Ph. D., P.E.

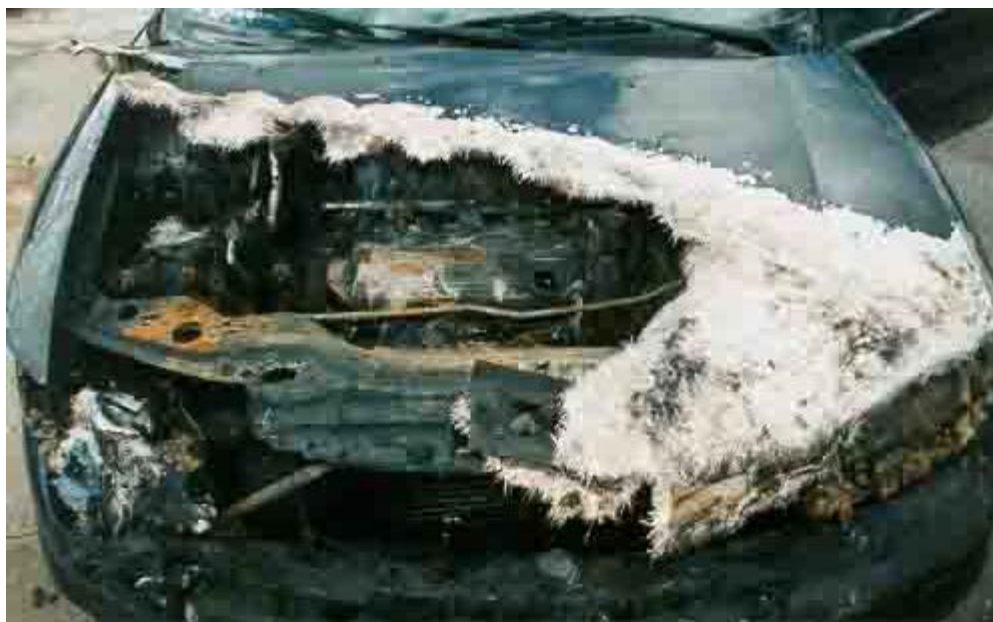
**Figure 1**

**Figure 1 is a view of a late model sedan that was being driven home from a radiator shop where the radiator had been repaired. The repair entailed draining and replacing the coolant. After driving several miles, the owner of the vehicle noticed smoke under the hood. The vehicle was stopped and a fire ensued in the engine compartment. Burn patterns in Figure 1 confirmed the engine compartment origin of the fire.**

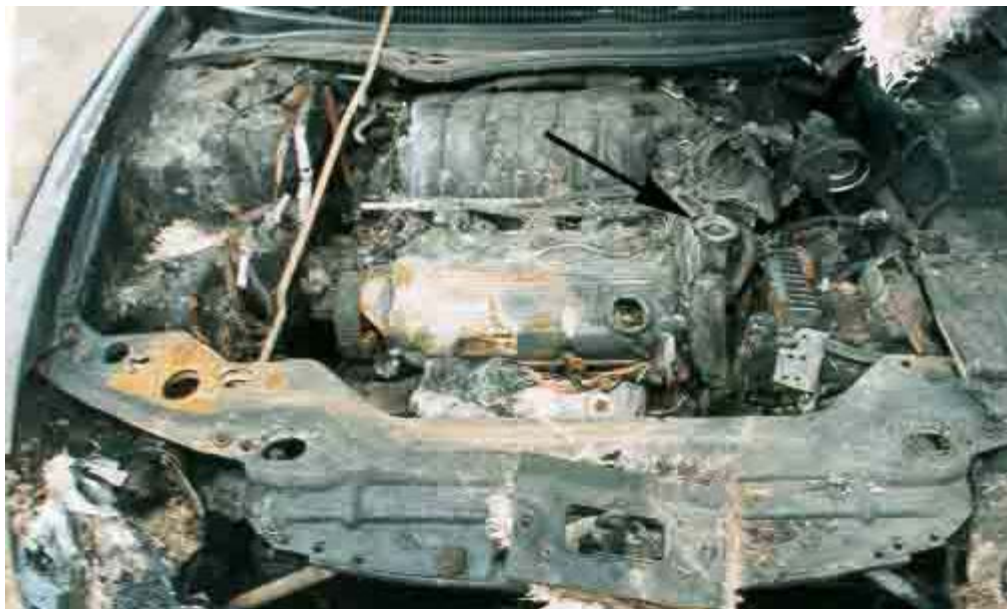
**Figure 2**

**Figure 2 is a closer view of the engine compartment with the hood raised. Inspection revealed an open engine coolant system cap as indicated by the arrow in Figure 2 and shown in detail in Figure 3. Apparently, the radiator coolant system cap was not found secured to the flange assembly.**

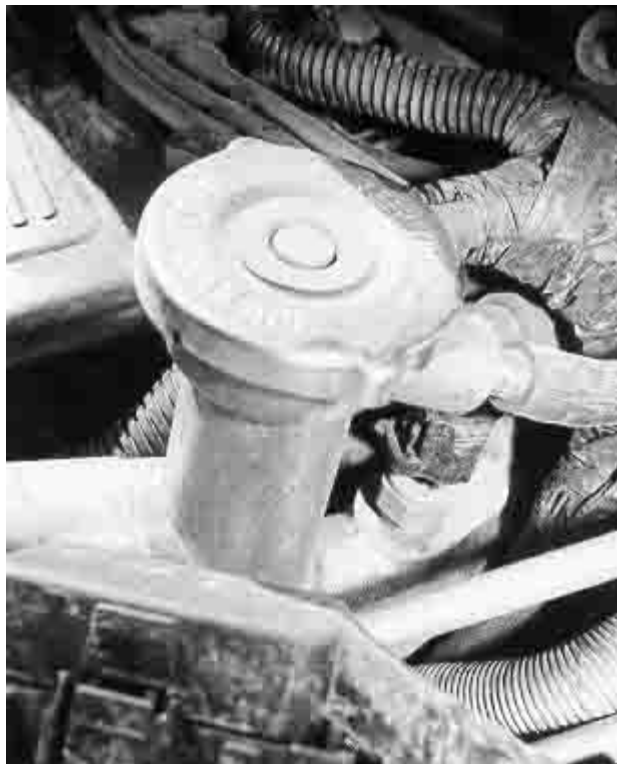
**Figure 4**

**Figure 4 shows an exemplar cap constructed of steel. The cap has a locking feature, which keeps it in place and reduces the chance of accidental removal when the coolant is hot. Because of the steel construction, such a cap would not be consumed in a fire of this magnitude and should have remained in place.**
