HOSE CLAMPS AND FLUID LEAKS

Charles C. Roberts, Jr.

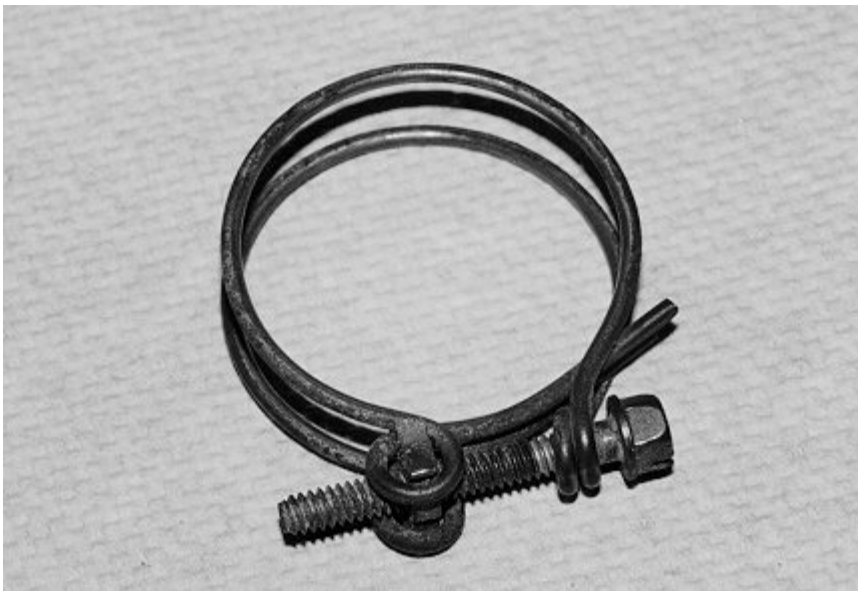
FIGURE 1

Fluid leaks resulting from deficiencies in hose clamps and/or hose clamp usage cause substantial losses, ranging from water damage in buildings to fuel leakage related fires in automotive vehicles. The Society of Automotive Engineers Standard J536b defines several hose clamp types designated as A,B,C,D,E and F. Figure 1 shows a type A clamp constructed of wire and a tightening screw which is typically used for large diameter rubber hoses such as radiator hoses. The type B clamp (Figure 2) has a similar tightening screw arrangement but is constructed of material in the shape of a band. The type C hose clamp (Figure 3) is constructed with a band

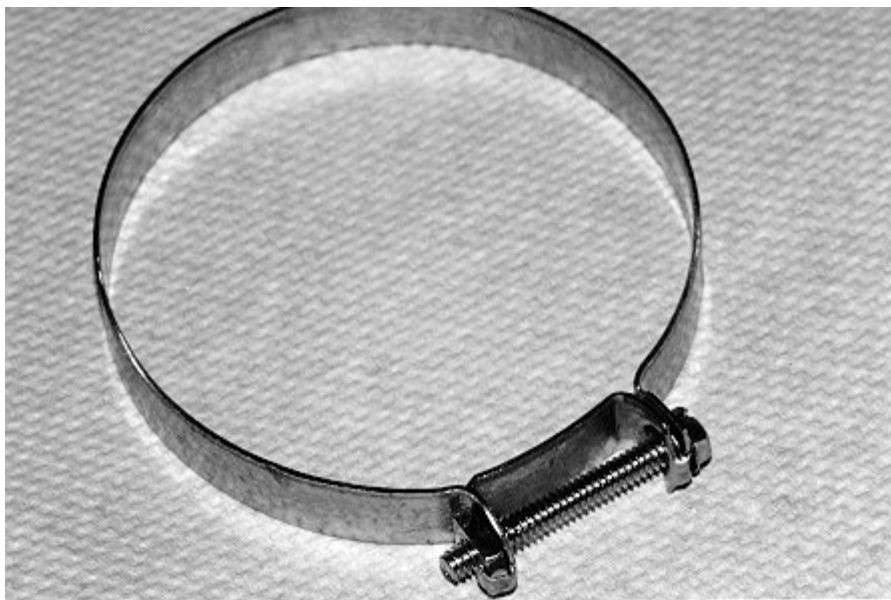
FIGURE 4

material and a slightly different arrangement for the clamping screw mount. The type D hose clamp (Figure 4) is similar to the type B design with slight differences in the clamping screw design. The type E hose clamp is an illustration of simplicity, being constructed of wire without the usage of a screw mechanism to provide clamping force (Figure 5). Finally the ubiquitous type F hose clamp utilizes a

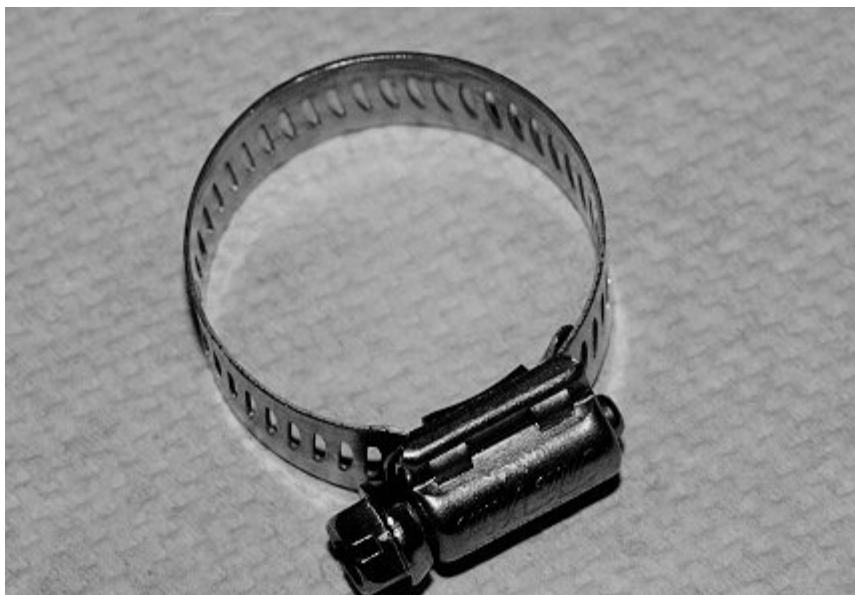
FIGURE 6

screw that directly engages the band material to provide clamping force (Figure 6). The type F design has the capacity of a wide range of opening diameter, yielding a flexible design but also an opportunity for misuse. Each of the hose clamps is designed for a particular hose size. The type E hose clamp in Figure 5 is a nominal 0.875 inches in diameter with a minimum of 0.85 inches and a maximum 0.90 inches. If the hose size is less than 0.85 inches, the hose will not be clamped properly. Likewise, a hose diameter larger than 0.90 inches would be too large to be clamped.

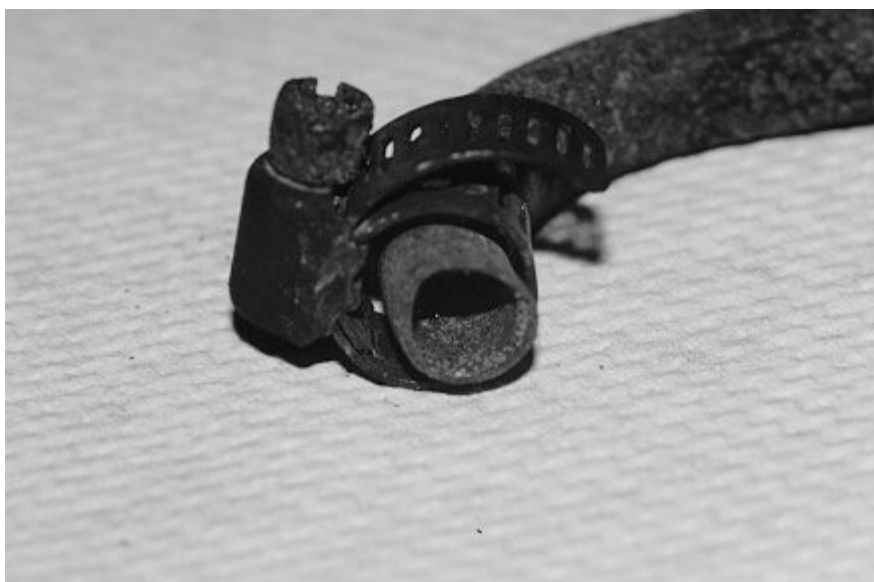
FIGURE 7

Figure 7 shows a hose clamp and fuel tube removed from a vehicle that was destroyed by fire, as a result of a fuel leak. Apparently, the mechanic providing carburetor repair service bent the fuel tube while making a repair. The tube was cut away at the damaged area and a fuel line with type F hose clamp was substituted as an inexpensive field expedient. As can be seen by the hose clamp band, it has been over-tightened which tends to extrude rubber through the opening in the band and causes damage to the fuel hose. Also, it should be noted that substituting rubber tubing for metal in high temperature environments can

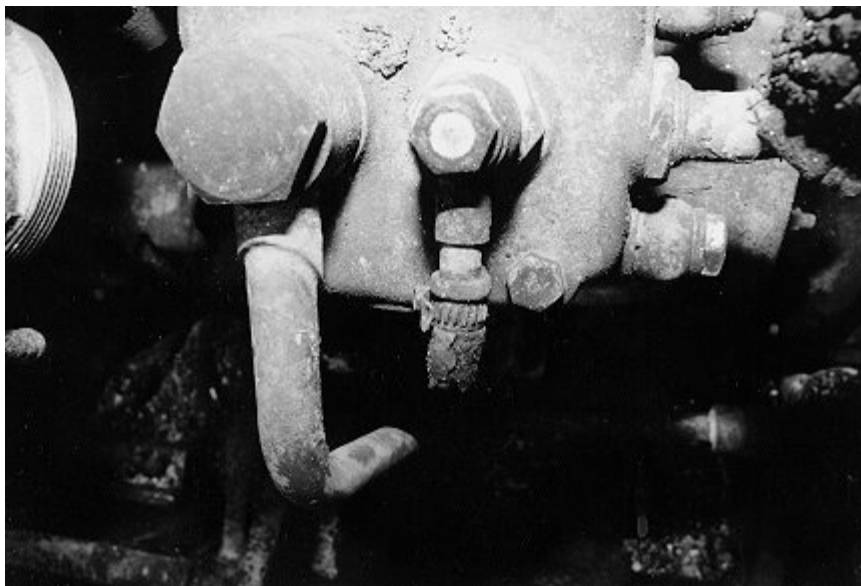
**FIGURE 8**

result in hose failure (see Claims, May 1992, “Fuel Line Fires May Result from Poor Maintenance”). In many instances, when fuel is leaking from fuel lines, the hose clamp is merely tightened until the leak stops. This often results in over-tightening of the clamp, damage to the fuel hose and a bigger leak. Sometimes a type F hose clamp is substituted for a type B hose clamp and over-tightened (which is not possible with a properly selected type B hose clamp), causing a similar loss. Figure 8 is an example of an over-tightened hose clamp, as evidenced by the rubber extruding through the band openings.

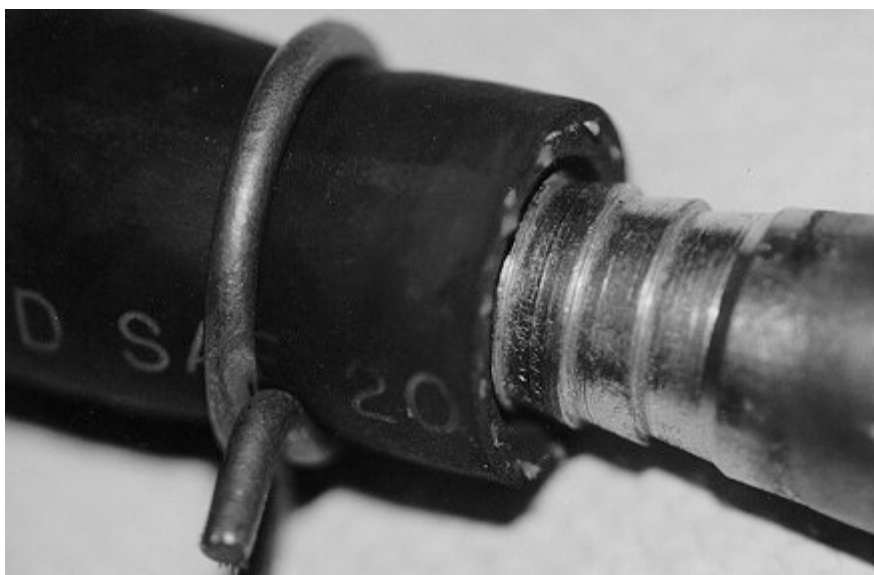
**FIGURE 9**

Figure 9 is a view of a type E hose clamp which was not fully engaged on a barb type fitting. This resulted in water leakage from the upstairs hot tub in a home, causing severe damage throughout the structure. The home was new and the plumber failed to water test all fittings prior to leaving. When the water was turned on in the new unoccupied home, the leak developed, causing the loss.
